Salford, Greater Manchester

Project description	Whole house retrofit of mid-terrace house, built c.1900.			
Treated Floor Area	70 m ²			
Dates of work	2008 – 2010			
Project team	Myself, along with various sub-contractors for different tasks			
Introduction	House was damp and dark when I bought it, and parts of the house (e.g. the bathroom) were freezing in cold weather. I had to do a certain amount of things anyway since the house was in a fairly bad state (e.g. window frames were rotten), so I found that this was a good time to try to make it better while I was at it. I didn't know much about energy efficiency or in what order to do things, so I spent some cash on a few books and read up about what I should do, after which I made a do-list and decided roughly in what order things should be done.			
Space heating demand & carbon emissions – before and after according to PHPP		Before	After	% reduction
	Space heating (kWh/m ² /yr)	299.3	102.9	66%

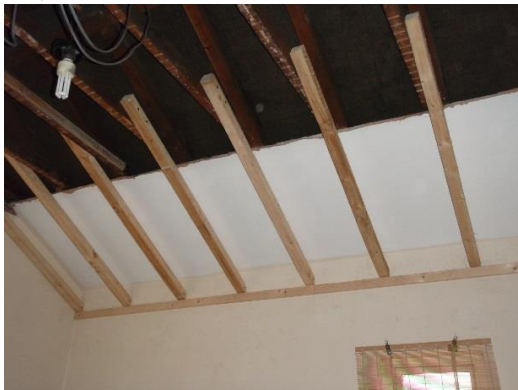
Primary energy (kWh/m ² /yr)	467.3	200.8	57%
	CO ₂ (kg/m ² /yr)	107.7	47.7	56%
Fuel use before and after	No data before, as I had just moved in. Data after retrofit does not give accurate picture due to many periods when house has been unoccupied, especially during cold months.			
What improvements done / strategies	Improvement	U-values / information		
	Insulation			
	Bathroom ceiling	- Polyisocyanurate (Kingspan) 120mm thick friction-fitted in rafters, u-value 0.321 W/m ² K

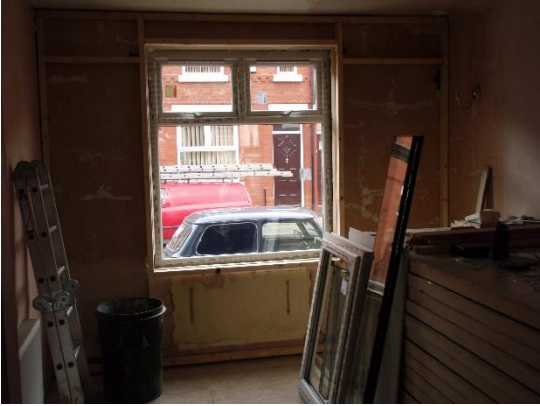
Internal walls (external-facing – i.e. not party walls)	- Polyisocyanurate (Kingspan) 70mm thick friction-fitted in studwork, u-value 0.372 W/m ² K

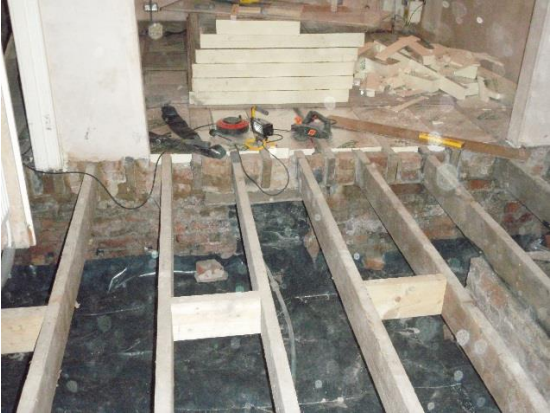
Suspended timber floor	<ul style="list-style-type: none"> - Polyisocyanurate (Kingspan) 100mm thick friction-fitted between joists, u-value 0.321 W/m²K

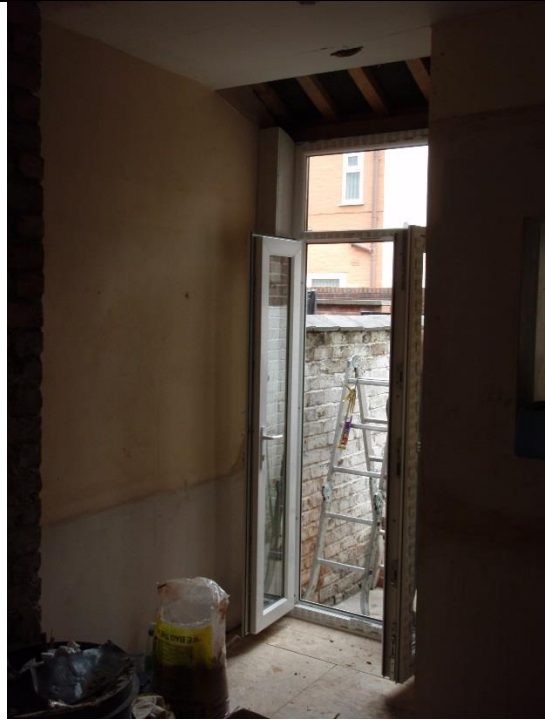
Loft	<ul style="list-style-type: none"> - Mineral wool 270mm thick, u-value 0.149 W/m²K
	Bay window ceiling above French doors	<ul style="list-style-type: none"> - Polyisocyanurate (Kingspan) 100mm thick friction-fitted between rafters, u-value 0.332 W/m²K

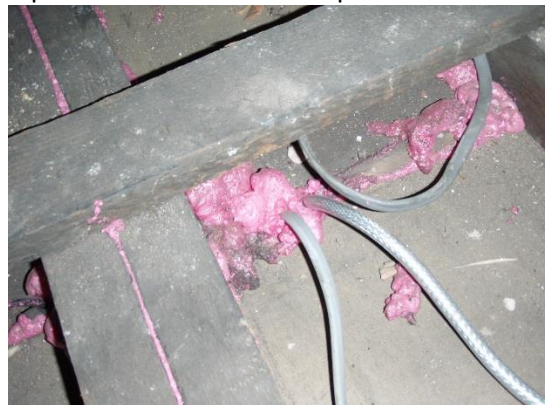
- Vapour-impermeable polythene sheets used on insulated internal walls and bathroom ceiling, but these were not adequately taped or sealed to create a draught proof barrier
- No membrane was used on ground floor – here I only relied on expanding foam
- No membrane used on bedroom ceilings – here I used expanding foam to seal up between plasterboards and wire penetrations via the loft space

What would I have done differently?	- Better airtightness using vapour-open materials (e.g. membranes or lime plaster): this was my first renovation, and following advice from a book, my airtightness strategy consisted largely of using expanding foam, which I

<p>now know is not an effective strategy. The polythene sheets were also not vapour-permeable, and in any case were not correctly joined together or to walls/floors.</p> <ul style="list-style-type: none"> - Wood fibre as insulation for internal wall insulation (avoiding any kind of vapour closed insulation for solid walls), and having WUFI analysis done for the most at-risk wall where u-value would be planned to be under 0.4 W/m²K - Proper MVHR design prior to procuring unit, to ensure that a lower flow rate can be achieved that would result in 0.3 air changes per hour in winter (to avoid dry air), also to ensure no air flow noise at terminals - Insulation for kitchen floor prior to concrete being laid - Better suspended floor insulation strategy – given what we now know about risk of moisture in joists, I would have taken the joists out and replaced with a recycled glass aggregate floor followed by a lime screed

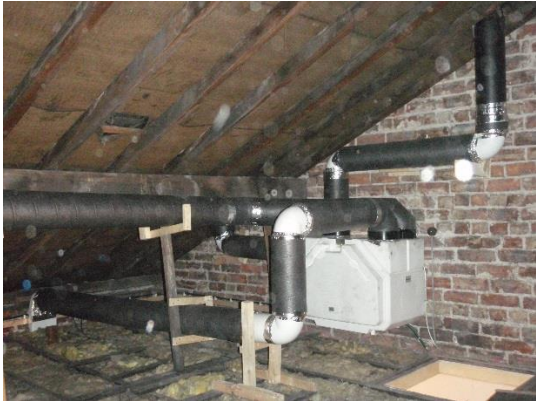
- Xpelair Xcell-300 unit installed in loft, 91% heat recovery
- Air is extracted from kitchen & bathroom and supplied to 2 bedrooms and lounge via 125mm round/rectangular ductwork and 180mm insulated ductwork in the loft space

<ul style="list-style-type: none"> - 82 m³/hour measured flow rate, which is the lowest flow rate possible before fans cut out – which means ventilation rate of 0.45 air changes per hour - Humidity in house varies within the 40-60% range, but occasionally dips below 40% in winter.

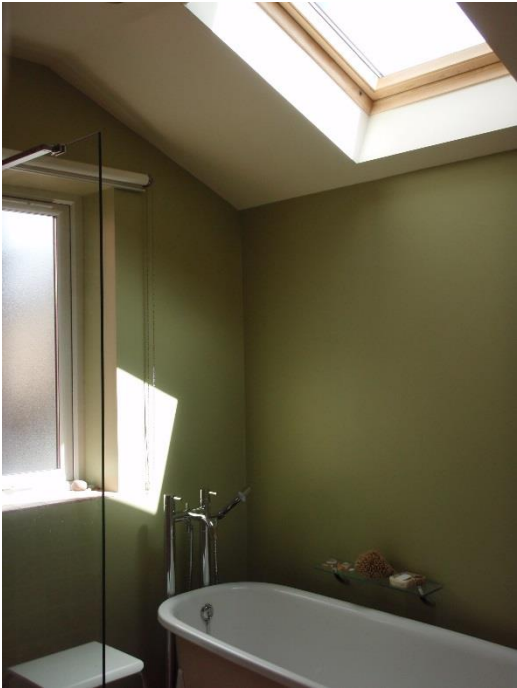
Doors & windows	
	New windows and doors	<ul style="list-style-type: none"> - Rehau PVC double-glazed windows and French doors, with 28mm gap argon-filled glazing, u-value of whole window 2.2 W/m²K (glazing u-value 1.5 W/m²K) - One Velux wood-framed window in bathroom, u-value of whole window 1.98 W/m²K (glazing u-value 1.1 W/m²K)

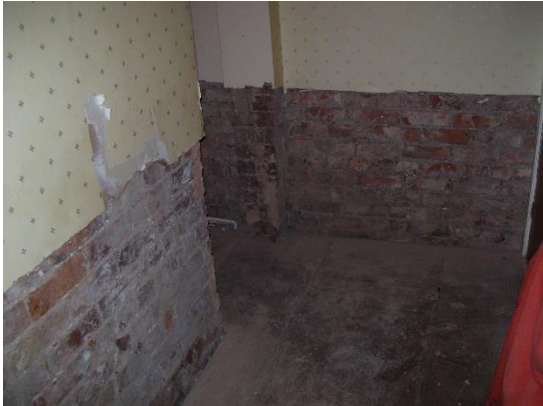
<ul style="list-style-type: none"> - Kitchen floor had to be drilled up and re-laid (rising damp due to inadequate DPM) - Keim Lotexan capillary block added on external face of walls to reduce amount of moisture soaking into the brickwork

Damp		
Ground floor & walls	<ul style="list-style-type: none"> - I had an injected damp course done on the whole ground floor

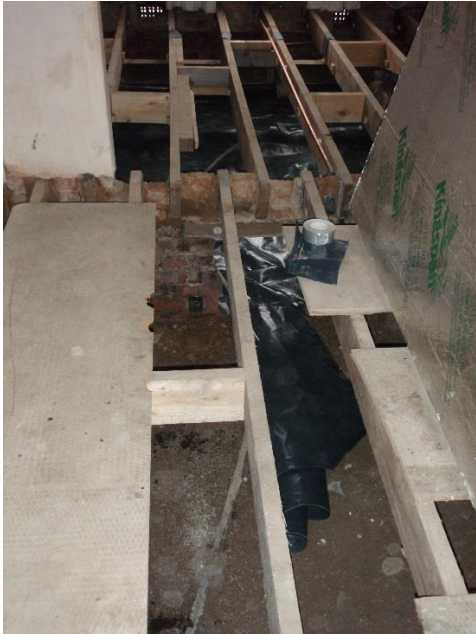
Crawl space	<ul style="list-style-type: none"> - Put 4.5 tonnes of MOT (gravel mix) onto the muddy crawl space floor to soak up moisture and deal with mud and unevenness - After that I laid a thick polythene sheeting on top of this to reduce evaporation (cleared up the condensation on windows overnight)
